**APPENDIX Biii**

**PHOTOGRAPHS RELATING TO THE EXPERIMENTAL FIRING PROGRAMME OF  
CHIMNEYS A, B & C**

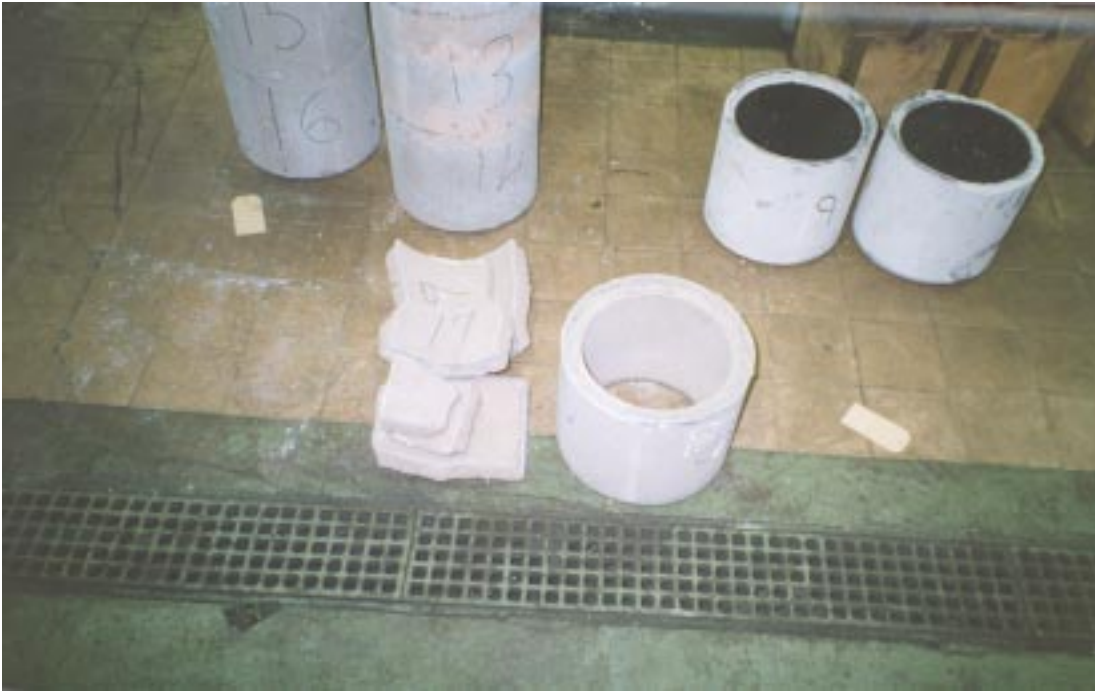
**Figure 1.1**

Photograph of the base of Chimney A after dismantling

NOTE: Broken liner No19 as found during dismantling, segments only lifted onto floor for photograph

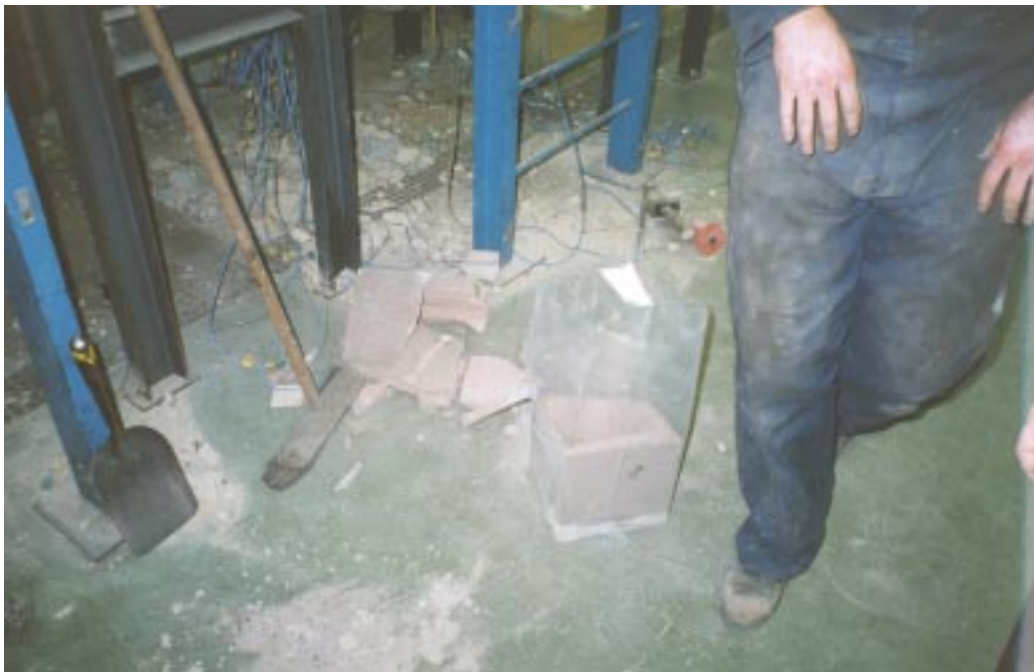
**Figure 1.2**

Photograph of the base of Chimney B after dismantling

Note: Broken liner No 8 was as found during dismantling, segments only lifted onto floor for photograph

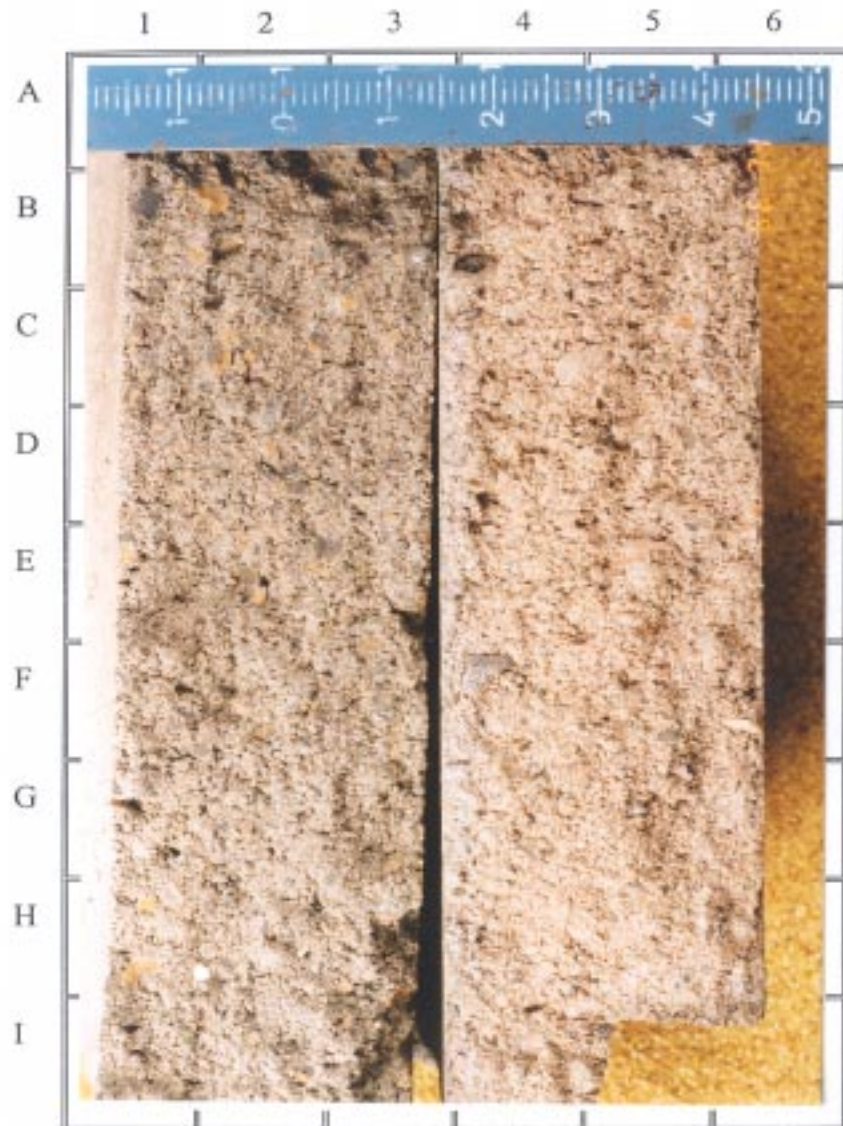
Figure 1.5

Photographs of liners from Chimney A (High Sand Content Zone)

Samples: 4760/3 (9L - Before)  
4760/3 A (9L 17 + 18 After)

*Broken surfaces.* This view shows the colour change between the unfired sample on the left side of the field of view and the fired sample which occurs on the right side of the field of view. The inner surfaces of the flue liners occur towards the right side.

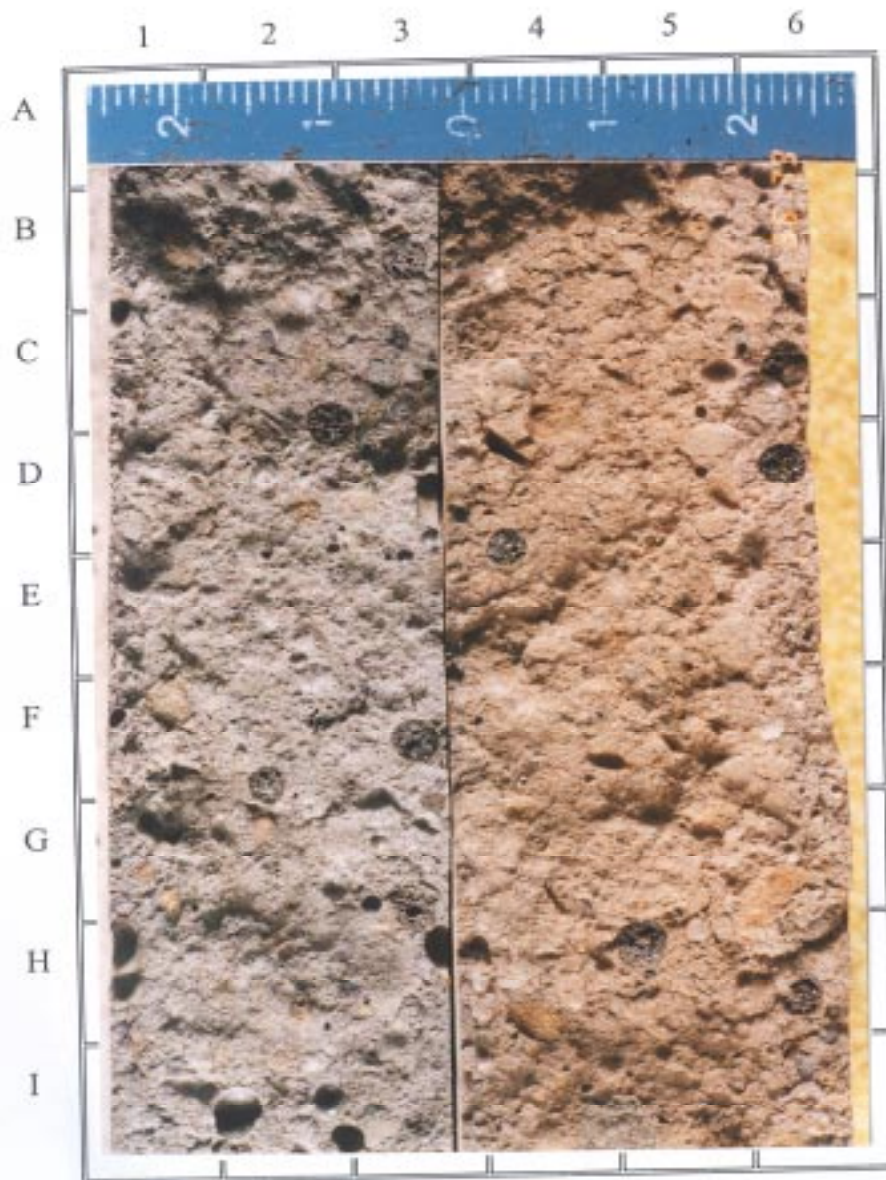
**Figure 1.6**

**Photographs of liners from Chimney B**

**4760/5 (Square (No.8 Top and Bottom) - After)**

**This view shows broken surfaces of the samples before and after firing. The fired sample occurs on the right side of the field of view, and the unfired sample on the left side of the field of view. The obvious reddening in the colour of the cement paste is readily visible.**
